State of Nebraska
Investigator's Motor Vehicle Accident Report

AGENCY CASE NO.
B5-093032

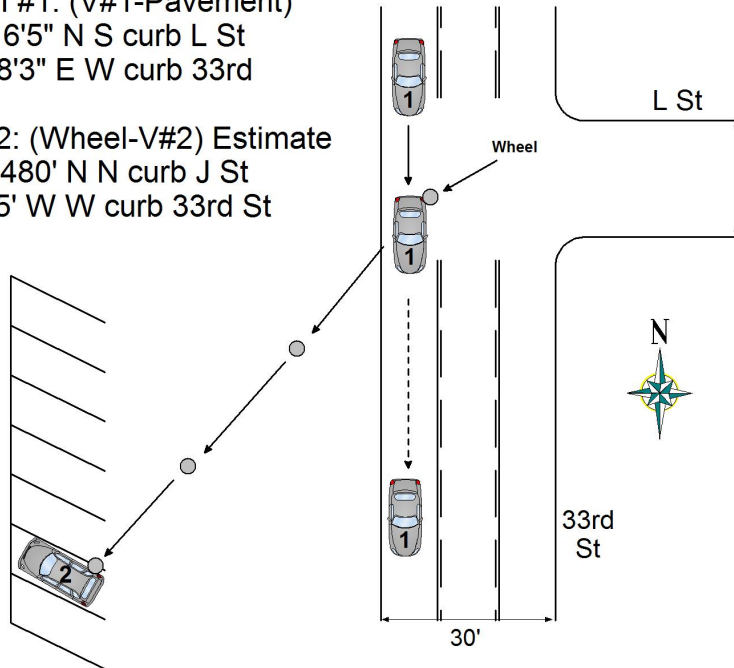
INDICATE BY DIAGRAM WHAT HAPPENED

POI #1: (V#1-Pavement)
6'5" N S curb L St
8'3" E W curb 33rd

POI #2: (Wheel-V#2) Estimate
480' N N curb J St
75' W W curb 33rd St

Parking Lot
Woods Tennis Center

V#1 was SB on 33rd at approx. L St when the LR wheel became disengaged from the vehicle and rolled right off the roadway approx. 170' before colliding into the side of V#2, which was parked in the east lot of Woods Park. V#1 continued SB for another 117', gouging the pavement before coming to a stop. D#1 reported that he'd just had his oil changed and tires rotated at Jiffy Lube, 33rd/O and had just driven away from the business. A technician there had neglected to tighten the lug nuts, three of which were located within a block of the accident scene.
